Removing and installing lateral acceleration sender -G200- and yaw rate sender -G202-

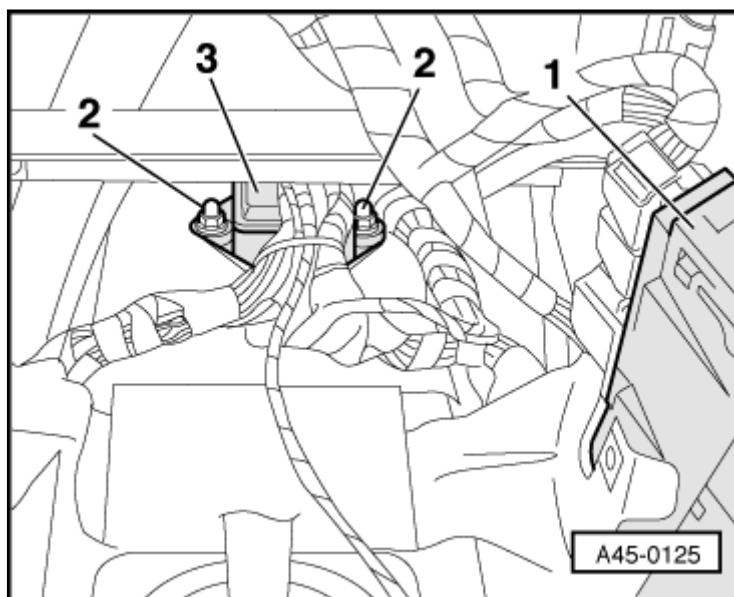
Lateral acceleration sensor is sensitive to

severe shocks or jolts.

If the sensor has been dropped by mistake it may not work properly and must not be installed in the vehicle.
